Customer Service Bulletin

SLM Electronics, Saint Louis, Missouri

CSB0008

Audio Centron ACM-8P

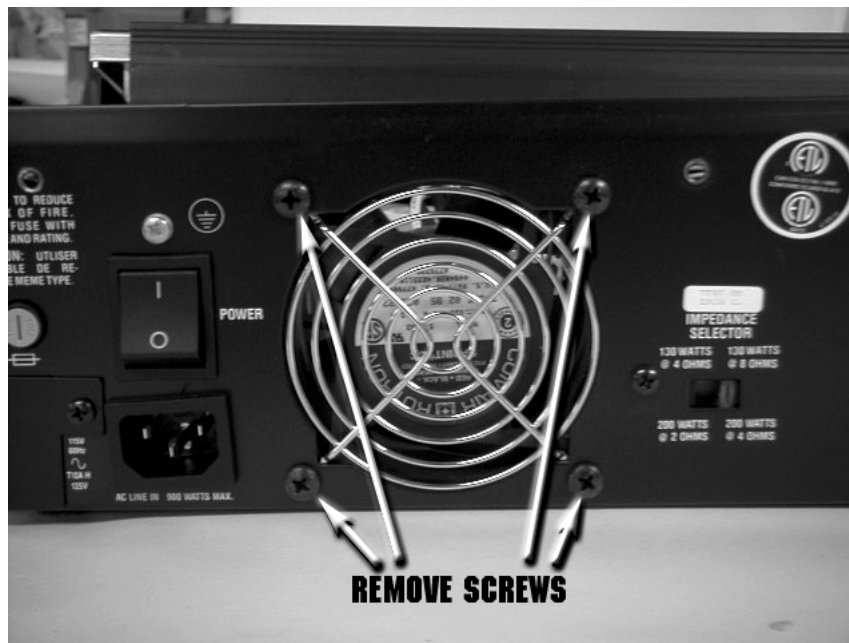
Internal cooling fan may be installed backwards, causing the unit to shut down prematurely under heavy operation.

7. Remove the four mounting screws from around the cooling fan (see photo below).

8. Lift the cooling fan straight up, out from the bottom chassis, and turn it around (see photo on next page). The directional indicator arrow on the top of the fan should be pointing OUT from the unit.
