Customer Service Bulletin

SLM Electronics, Inc. Saint Louis, Missouri

CSB0006

<u>Model</u>	<u>Serial Number</u>
Audio Centron RMA-1650	ARODK80001 through ARODK80024
Audio Centron RMA-1601	ARNDK80001 through ARNDK80044

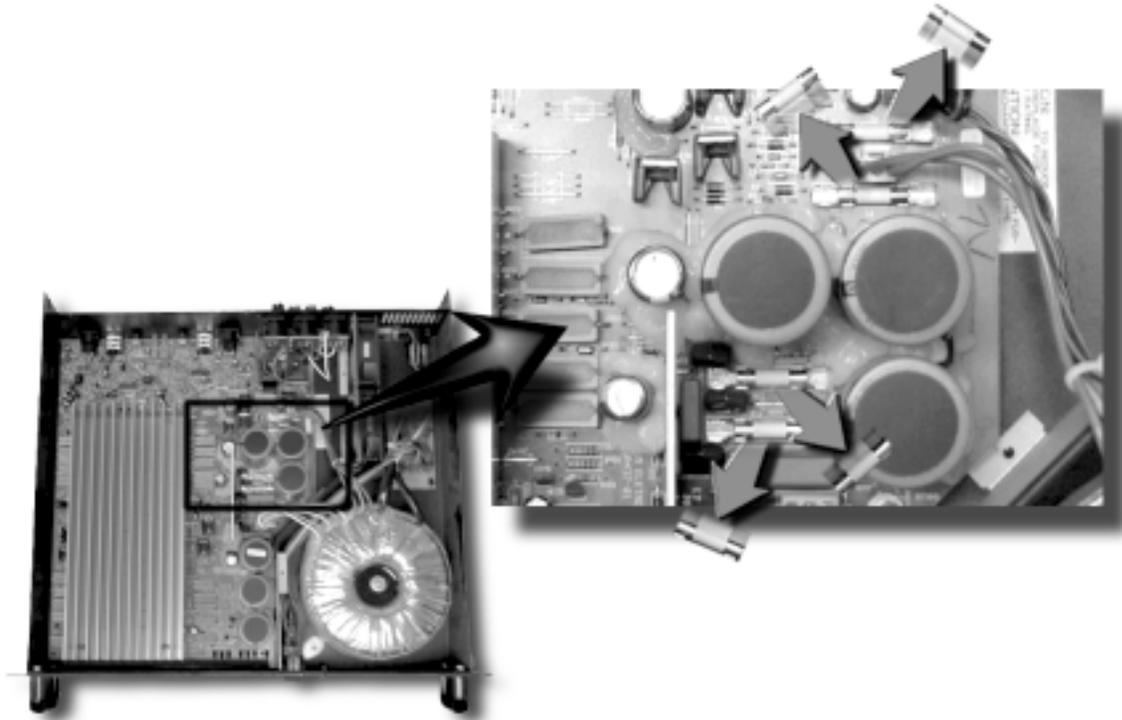
Figure 1: Removal of the internal fuses

Remove T1A fuses, four places (F1 - F4) - replace with 3AG 1A slo-blo #23-301-05.

1. Unplug the unit.
2. Remove the 9/64" drive socket screw from the top-center of the faceplate. Remove the ten small phillips-head screws from the top cover (three along each side, three along the rear, and one on the top). Remove the top cover.
3. Locate the four internal fuses (F1 - F4), remove them as shown in Figure 1 on page 2 and discard them.
4. Replace each of the four fuses with SLM part number 23-301-05 3AG 1A slo blo fuses. (Note that even though the replacement fuses are longer than the original fuses, they still snap down into the same fuse holders.)
5. Replace the top cover and tighten the screws. Do not overtighten.
